BESS BRANNEN ELEMENTARY

EXECUTIVE SUMMARY

Floor Plans

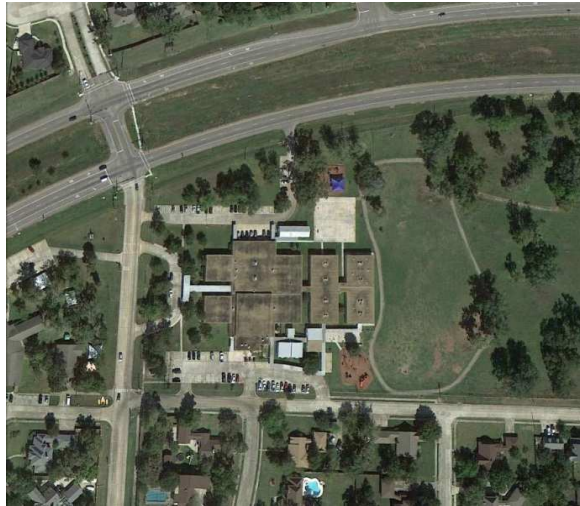
Site Conditions

Overall fair condition

Overall maintained/fair condition, some cracking at sidewalks.

Drainage is in fair condition.

Special Notes or Observations
Drainage is in fair condition.
Low areas surrounding sidewalks.
Existing lighting, minimal.
Fair condition, minimal cracking.
Fair condition, some maintenance needed at foot walls.
Overall fair condition
Striping throughout needs repainting.
Access to campus inadequate due to lane and parking lot conflict.
Overall maintained/fair condition, some cracking at sidewalks.
Reconsider rock ground cover near front door, potential security issue.
Fair condition, some repair/maintenance issues.
Well maintained.
Concrete play surface has minor cracking.
Backboards/goals need replacment.
Good/fair condition.
Accessible, good condition.
Good condition.
Mulch fall surface, consider replacing.
